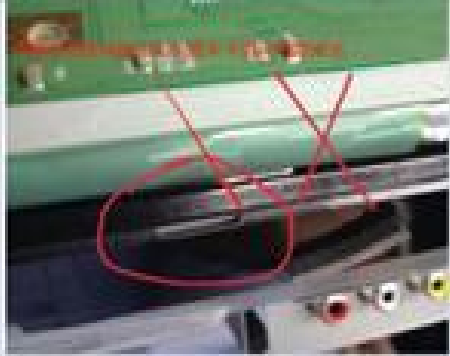
| No. | Case information | Picture |
|---|---|---|
| 1 | <p><u>Defective phenomenon</u> : Leakage of light</p> <p><u>Reason analysis</u>:</p> <p>Operation problem, the middle frame and the hardware backboard buckle is not in place, resulting in leakage of light.</p> <p><u>Maintenance measure</u></p> <ol style="list-style-type: none"> <li>1. Disassemble the machine and lock the buckle between the middle frame and the hardware backboard to the right position;</li> </ol> | |

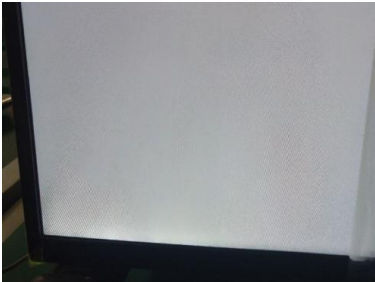
| No. | Case information | Picture |
|---|---|---|
| 2 | <p><u>Defective phenomenon</u> : Shadow</p> <p><u>Reason analysis</u> :</p> <ol style="list-style-type: none"> <li>1. Checked the light guide plate, and the assembly of the light guide plate has been put in place;</li> <li>2. Checked the light bar, and found that the light bar was not pressed in place, and the light bar was higher than the edge of the backboard.</li> </ol> <p><u>Maintenance measure</u></p> <ol style="list-style-type: none"> <li>1. Removed the light bar which was not pressed in place;</li> <li>2. Reattached the light bar to the edge of the backboard and pressed it in place. The edge of the light bar should not be higher than the edge of the backboard.</li> </ol> | |

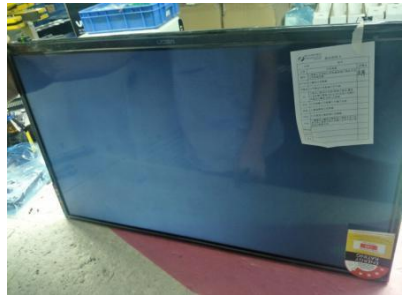
| 5 | <p><u>Defective phenomenon</u> : Grey screen</p> <p><u>Reason analysis</u> :</p> <p>Checked the LVDS cable, and the LVDS cable was inserted backwards.</p> <p><u>Maintenance measure</u> :</p> <p>Disassembled the machine and inserted the LVDS in place.</p> | |

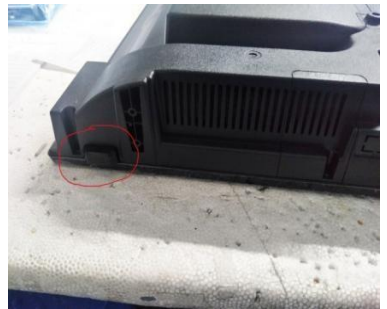
| 6 | <p><u>Defective phenomenon</u> : The light of IR board no working</p> <p><u>Reason analysis</u> :</p> <p>Checked the IR board/key board, and the cable of IR board/key board was not inserted in place</p> <p><u>Maintenance measure</u> :</p> <p>disassembled the machines and inserted the cable of IR board/key board in place.</p> | |

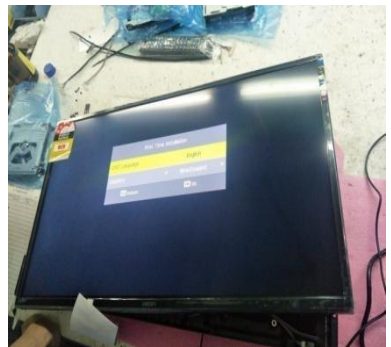
| 7 | <p><u>Defective phenomenon</u> : Key board no working</p> <p><u>Reason analysis</u> :</p> <p>1. Checked the cable of IR board/key board, and IR board/key board was inserted in place</p> <p>2. Replaced the key board, and key board worked. Thus reason lies on deficient purchase.</p> <p><u>Maintenance measure</u> :</p> <p>disassembled the machines and replaced the key board</p> | |

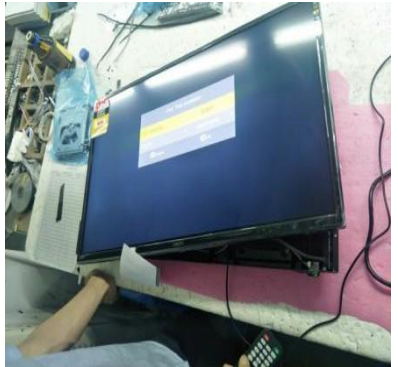
| 9 | <p><b><u>Defective phenomenon</u></b> : No working remote control</p> <p><b><u>Reason analysis</u></b> :</p> <ol style="list-style-type: none"> <li>1. Checked the cable of IR board/key board, and they were inserted in place;</li> <li>2. Replaced the IR board/key board and the cable module, and the remote control worked;</li> <li>3. Replaced the IR board, and the remote control did not work. Thus the reason lies in defective cable of IR board/key board.</li> </ol> <p><b><u>Maintenance measure</u></b> : _____</p> <p>disassembled the machines and replaced the IR board/key board.</p> | |

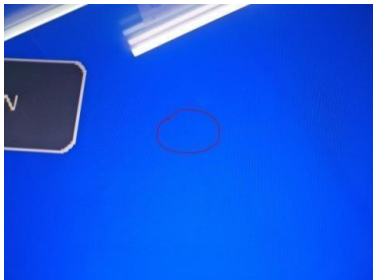
| 10 | <p><b><u>Defective phenomenon</u></b> : Foreign matter</p> <p><b><u>Reason analysis</u></b> :</p> <p>Checked the liquid crystal glass, and found that the foreign matter was on the liquid crystal glass</p> <p><b><u>Maintenance measure</u></b> :</p> <p>disassembled the machine, and remove the foreign matter on the liquid crystal glass.</p> | |

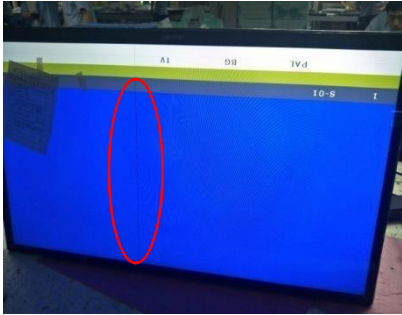
| 11 | <p><b><u>Defective phenomenon</u></b> : bright line</p> <p><b><u>Reason analysis</u></b> :</p> <p>Checked the liquid crystal glass, and found that COF of liquid crystal glass had been damaged</p> <p><b><u>Maintenance measure</u></b> :</p> <p>disassembled machine, and replaced liquid crystal glass.</p> | |

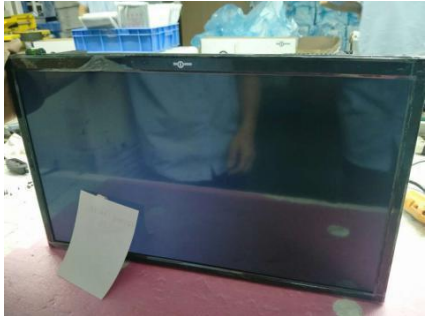
| 12 | <p><b><u>Defective phenomenon</u></b> : Grey screen</p> <p><b><u>Reason analysis</u></b> :</p> <ol style="list-style-type: none"> <li>1. Checked the LVDS cable, and it was inserted in place</li> <li>2. Checked the liquid crystal glass, and found that the COF of liquid crystal glass had been damaged.</li> </ol> <p><b><u>Maintenance measure</u></b> :</p> <p>disassembled the machine and replaced the liquid crystal glass.</p> | |

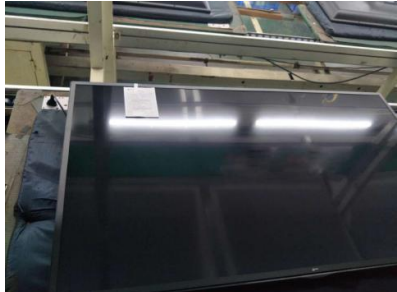
| 13 | <p><b><u>Defective phenomenon</u></b> : Black screen</p> <p><b><u>Reason analysis</u></b> :</p> <ol style="list-style-type: none"> <li>1. Checked the LVDS cable, and it was inserted in place</li> <li>2. Checked the power board, and found that the insulating strip on the the power board had been assembled in a wrong position, resulting short circuit.</li> </ol> <p><b><u>Maintenance</u></b> :</p> <p>disassembled the machine, and set the insulting strip between the power board and main board.</p> | |

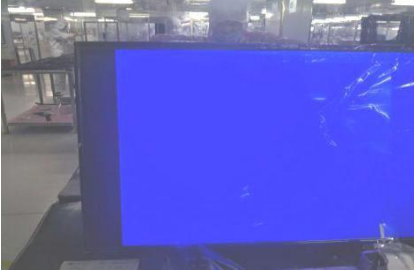
| 14 | <p><u>Defective phenomenon</u> : Block 1</p> <p><u>Reason analysis</u> :</p> <p>Checked FFC cable, FFC cable was not inserted in place.</p> <p><u>Maintenance measure</u> :</p> <p>Inserted FFC cable</p> | |

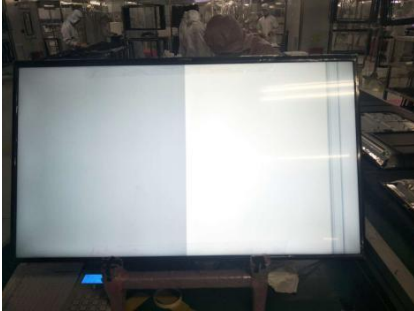
| 15 | <p><u>Defective phenomenon</u> : Block 2</p> <p><u>Reason analysis</u> :</p> <ol style="list-style-type: none"> <li>1. Checked FFC cable and FFC cable was inserted in place</li> <li>2. Checked the COF and found that COF damage.</li> </ol> <p><u>Maintenance measure</u> :</p> <p>disassembled the machine, and replaced the liquid crystal glass.</p> | |

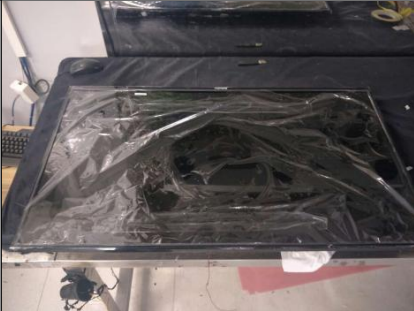
| 16 | <p><u>Defective phenomenon</u> : Backlight no working</p> <p><u>Reason analysis</u> :</p> <p>Checked the backlight cable, and found one of the cables fell off.</p> <p><u>Maintenance measure</u> :</p> <p>disassembled the machine, and inserted the fell-off cable into the corresponding sockets. Meanwhile the backlight cable can not be pulled too tight.</p> | |

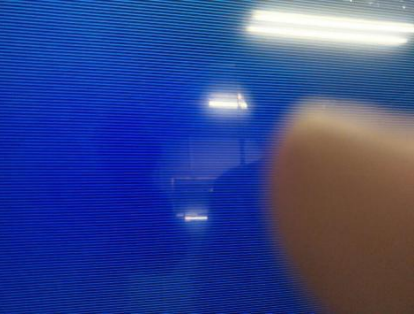
| 17 | <p><u>Defective phenomenon</u> : Grid coarsening</p> <p><u>Reason analysis</u> :</p> <ol style="list-style-type: none"> <li>1. Checked the FFC cable, and FFC cable was inserted.</li> <li>2. Replaced T-CON board, and the machine was normal. So that the reason lies on deficient purchase of T-con board</li> </ol> <p><u>Maintenance measure</u> : _____</p> <p>Replaced T-CON board</p> | |

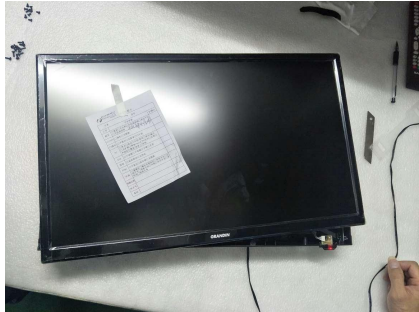
| 18 | <p><u>Defective phenomenon</u> : can not remote control</p> <p><u>Reason analysis</u> :</p> <p>Checked the cable of key board and found that one of the cables fell off</p> <p><u>Maintenance measure</u> :</p> <p>disassembled the machine, and inserted the cable in place</p> | |

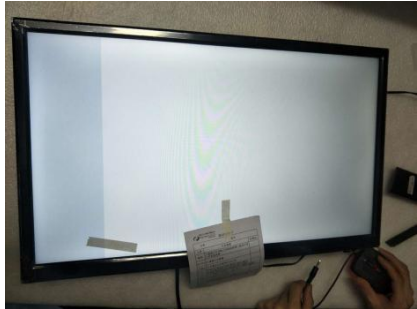
| 19 | <p><u>Defective phenomenon</u> : Defective image</p> <p><u>Reason analysis</u> :</p> <p>Checked the COF of the glass, and found that COF fell off</p> <p><u>Maintenance measure</u> :</p> <p>disassembled the machine and replaced the liquid crystal glass</p> | |

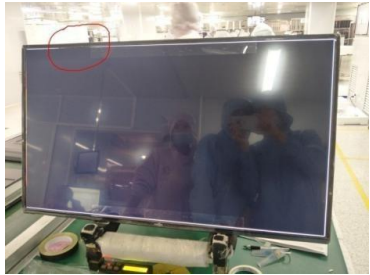
| 21 | <p><u>Defective phenomenon</u> : press the edge</p> <p><u>Reason analysis</u> : _____</p> <ol style="list-style-type: none"> <li>1. Checked the glass, and it was in the right place</li> <li>2. Checked the backboard, and it was out of shape</li> </ol> <p><u>Maintenance measure</u></p> <p>disassembled the machine, and replaced the backboard</p> | |

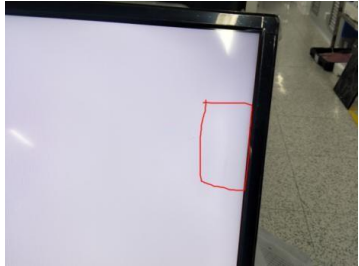
| 22 | <p><u>Defective phenomenon</u> : bright line</p> <p><u>Reason analysis</u> : _____</p> <p>Checked the reflector plate, and it was not smooth with local cock.</p> <p><u>Maintenance measure</u> : _____</p> <p>disassembled the machine and smoothed the reflector plate in place.</p> | |

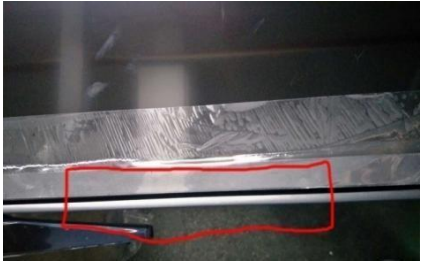
| 23 | <p><u>Defective phenomenon</u> : divided cover</p> <p><u>Reason analysis</u> :</p> <p>Checked the back cover, and it was in the right place</p> <p>Checked the back cover, and it was out of shape</p> <p><u>Maintenance measure</u> :</p> <p>disassembled the machine, replaced the back cover</p> | |

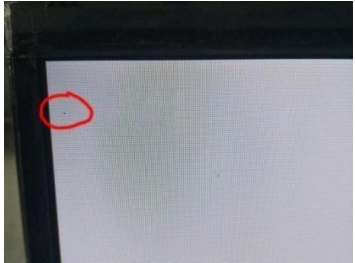
| 24 | <p><u>Defective phenomenon</u> : bright spot</p> <p>Checked the liquid crystal glass, bright spot with blue is in the liquid crystal glass.</p> <p><u>Maintenance measure</u> :</p> <p>disassembled the machine, and replaced the liquid crystal glass.</p> | |

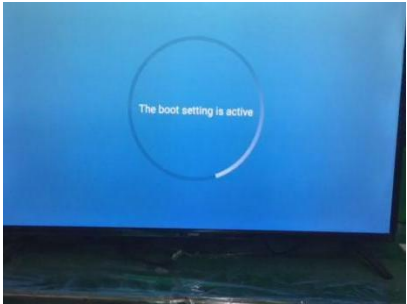
| 25 | <p><u>Defective phenomenon</u> : automatically shutdown</p> <p><u>Reason analysis</u> :</p> <p>Replaced the main board, and the phenomenon was solved. Thus the reason lies in defective main board.</p> <p><u>Maintenance measure</u> :</p> <p>disassembled the machine, and replaced the main board.</p> | |

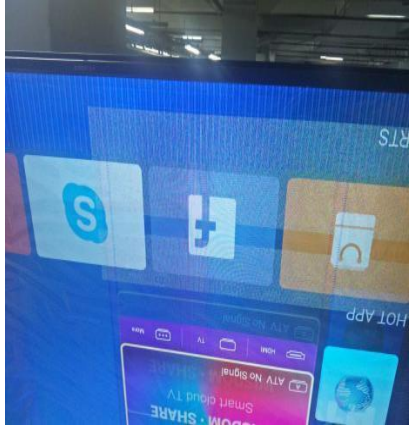
| 26 | <p><b><u>Defective phenomenon</u></b> : flickering screen</p> <p><b><u>Reason analysis</u></b> :</p> <p>Checked the LVDS cable, and it was in the right place.</p> <p>Checked the glass, and the PC plug on the PCB board was damaged.</p> <p>Replaced the T-con board, the screen was still flickering</p> <p>Replaced the main board, the phenomenon was solved. So that the reason lies in the defective main board</p> <p><b><u>Maintenance measure</u></b> : _____</p> <p>Disassembled the machine, and replaced the main board.</p> | |

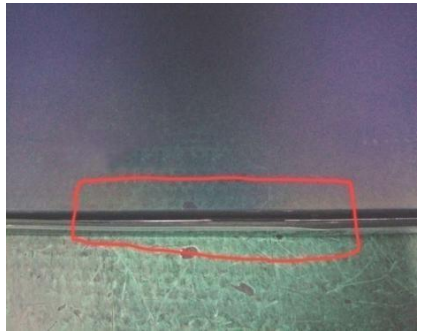
| 27 | <p><b><u>Defective phenomenon</u></b> : divided cover</p> <p><b><u>Reason analysis</u></b> :</p> <p>Checked the front frame, and the ground side of the front frame was out of shape.</p> <p><b><u>Maintenance measure</u></b> :</p> <p>Disassembled the machine, add the double-side tape to reinforce the front frame on the ground side of front frame.</p> | |

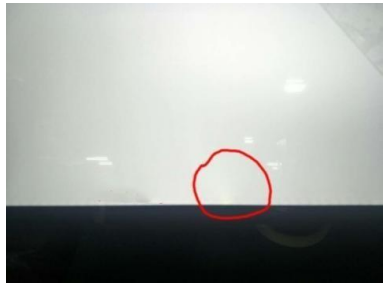
| 28 | <p><b><u>Defective phenomenon</u></b> : yellow back light</p> <p><b><u>Reason analysis</u></b> :</p> <p>Checked the light bar, and found that one of the LED was defective with yellow color.</p> <p><b><u>Maintenance measure</u></b> :</p> <p>Disassembled the machine, and replaced the light bar</p> | |

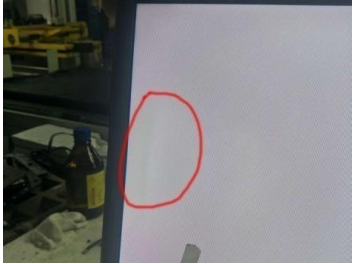
| 29 | <p><b><u>Defective phenomenon</u></b> : watermark</p> <p><b><u>Reason analysis</u></b> :</p> <p>Checked the liquid crystal glass, the appearance of the Glass was attached with watermark</p> <p><b><u>Maintenance measure</u></b> :</p> <p>Disassembled the machine, and replaced the liquid crystal glass</p> | |

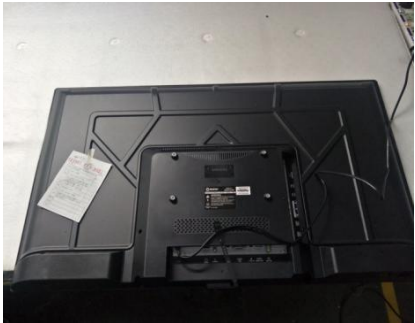
| 30 | <p><b><u>Defective phenomenon</u></b> : tremolos</p> <p><b><u>Reason analysis</u></b> :</p> <p>Checked the speakers, and the speakers module was normal<br/>Checked PCB board, and found that tremolos was due to loose PCB board</p> <p><b><u>Maintenance measure</u></b> :</p> <p>Disassembled the machine, and attached the PCB board steadily with acetic acid cloth tape.</p> | |

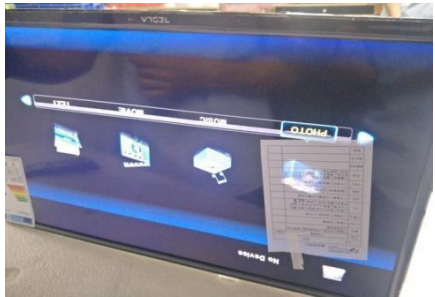
| 31 | <p><b><u>Defective phenomenon</u></b> : no sound in left speaker.</p> <p><b><u>Reason analysis</u></b> :</p> <p>Checked the speakers cable and the cable of the left speaker was parted</p> <p><b><u>Maintenance measure</u></b> :</p> <p>Disassembled the machine, and connected the speakers cable which was parted</p> | |

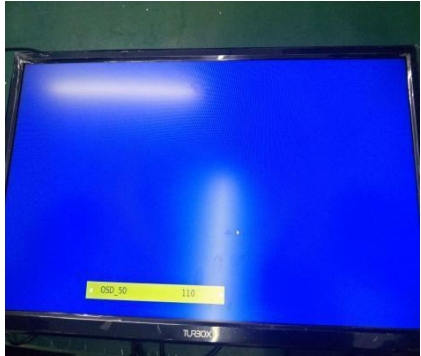
| 32 | <p><b><u>Defective phenomenon</u></b> : water ripple</p> <p><b><u>Reason analysis</u></b> :</p> <p>Checked the channel, and found that water ripple was existing on the channel VGA only, and it can not be found on other channel.</p> <p>Checked the software, and adjusted the brightness/contrast, the phenomenon had been improved to a certain extent but not be disappeared</p> <p>Replaced the main board, the phenomenon had been disappeared. So that the reason lies in defective main board.</p> <p><b><u>Maintenance measure</u></b> :</p> <p>Disassembled the machine, and replaced the main board</p> | |

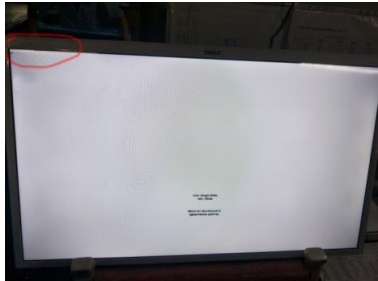
| 33 | <p><b><u>Defective phenomenon</u></b> : BEF had a gap</p> <p><b><u>Reason analysis</u></b> : _____</p> <p>Checked the bright enhancement film and it was not in the Right place. The spacing between the top and bottom registration masts of the back board was discrepant with the spacing of loops on the film, causing the loop cannot be locked on the registration masts</p> <p><b><u>Maintenance measure</u></b> :</p> <p>Disassembled the machine, cut off the bottom loop of the film, smoothed the film into the backboard ensuring top loop of the film could locked on the registration masts</p> | |

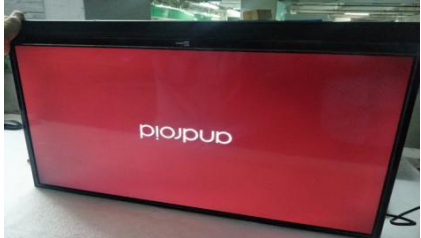
| 34 | <p><b><u>Defective phenomenon</u></b> : defective image</p> <p><b><u>Reason analysis</u></b> :</p> <p>Checked the LVDS cable, the PCB board end of the LVDS cable was not inserted in place</p> <p><b><u>Maintenance measure</u></b> :</p> <p>Disassembled the machine, and inserted the LVDS cable in place</p> | |

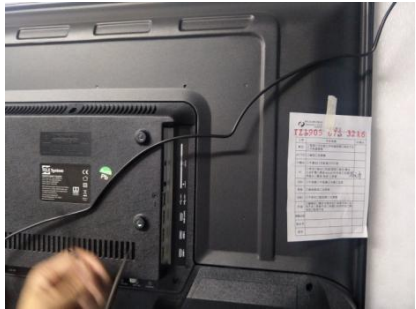
| 35 | <p><b><u>Defective phenomenon</u></b> No sound: in the right speaker</p> <p><b><u>Reason analysis</u></b> :</p> <p>Checked the speakers, one cable of the right speaker connected abnormally</p> <p><b><u>Maintenance measure</u></b> :</p> <p>Disassembled the machine, and inserted the cable into the right sockets in place</p> | |

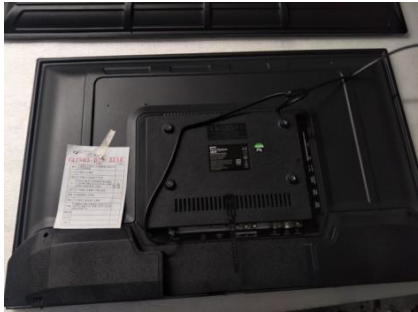
| 36 | <p><b><u>Defective phenomenon</u></b> : no sound</p> <p><b><u>Reason analysis</u></b> :</p> <ol style="list-style-type: none"> <li>1. Checked the speakers, and the cables was in the right place</li> <li>2. Checked the cables, and found that the one of those had been pressed by the back cover causing short-circuit by the insulating layer laceration.</li> </ol> <p><b><u>Maintenance measure</u></b> :</p> <p>Disassembled the machine, covered the place of laceration in insulating tape and arranged the cables in terms of operation standard</p> | |

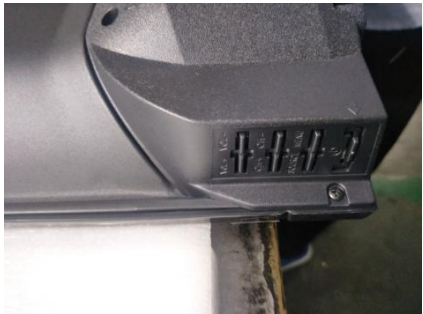
| 37 | <p><b><u>Defective phenomenon</u></b> : the menu button can not bounce back</p> <p><b><u>Reason analysis</u></b> :</p> <p>Checked the plastic button on the back cover and it was out of shape, causing it can not bounce back</p> <p><b><u>Maintenance measure</u></b> :</p> <p>Disassembled the machine and replaced the cover</p> | |

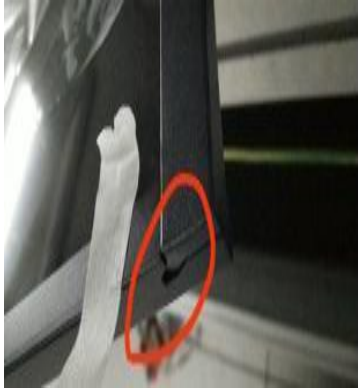
| 39 | <p><b><u>Defective phenomenon</u></b> : the front frame was not in the right place ;</p> <p><b><u>Reason analysis</u></b> :</p> <p>Caused by the front frame being out of shape</p> <p><b><u>Maintenance measure</u></b> :</p> <p>Disassembled the front frame, redressed the place of out of shape in right place.</p> | |
